# Manhole Inspection Summary

Manhole # S65O\_\_009MH

**Location** Address: **1249 Broening Hwy.**

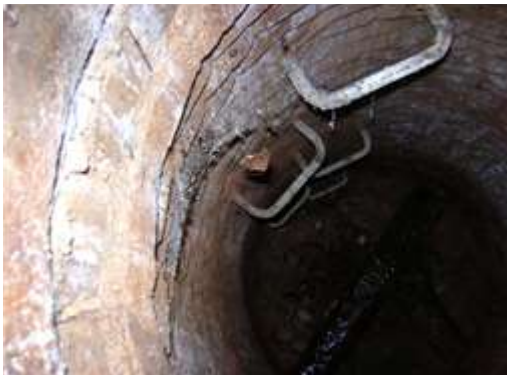
Defect 3

deterioration

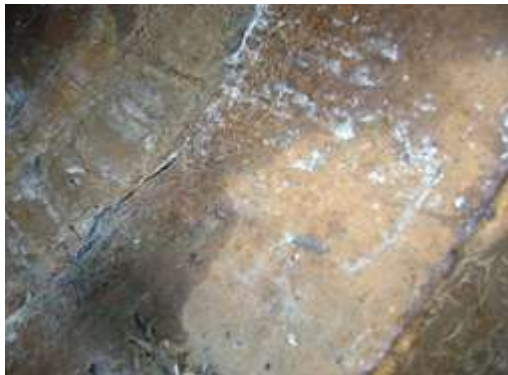
Defect 2

deterioration

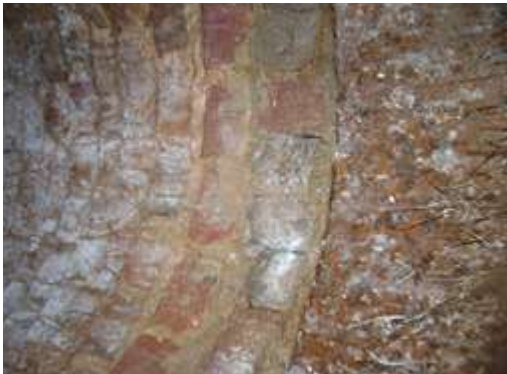
Defect 1

infiltration

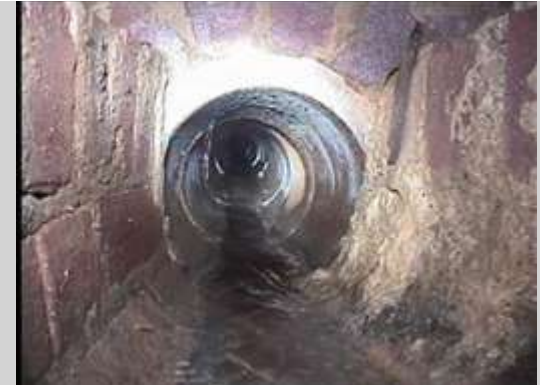
12 O'Clock Outflow

8 in. Circular Gravity Sewer  
Pipe Out @ 12 O'Clock

Pipe Height: **8.4** (in.) Rod and Bar (Angled)  
Pipe Material: **Clay** ☐ Pipe Lined  
Invert Depth: **10.42** (ft.) Flow Characteristics: **Slow**  
Deposits: ☒ None ☐ Mud ☐ Sludge ☐ Debris ☐ Grease  
Silt Depth: (in.) Deposits Extent:  
Infiltration: **None** Pipe Seal Cond: **Sound**

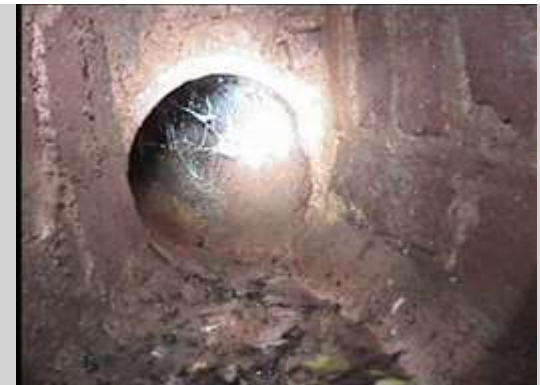
3 O'Clock Inflow

6 in. Circular Gravity Sewer  
Pipe In @ 3 O'Clock

Pipe Height: **6** (in.) Rod and Bar (Angled)  
Pipe Material: **Clay** ☐ Pipe Lined  
Invert Depth: **10.33** (ft.) Flow Characteristics: **Slow**  
Deposits: ☒ None ☐ Mud ☐ Sludge ☐ Debris ☐ Grease  
Silt Depth: (in.) Deposits Extent:  
Infiltration: **None** Pipe Seal Cond: **Sound**

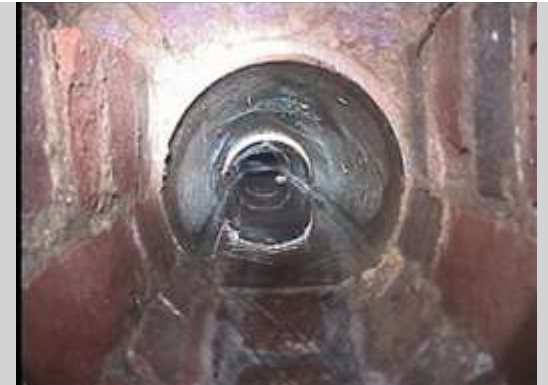
6 O'Clock Inflow

8 in. Circular Gravity Sewer

Pipe In @ 6 O'Clock

Pipe Height: **8.4** (in.) Rod and Bar (Angled)

Infiltration: **None** Pipe Seal Cond: **Sound**
